# Roof flashing cover upgraded with Belzona

ID: 10040

Customer Location: Mansfield  
Application Date: September 2022

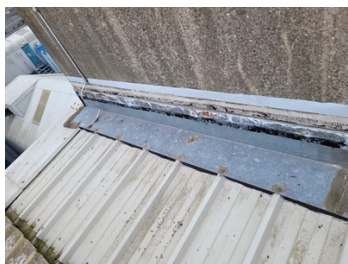
A roof flashing had become detached from the concrete side wall, leading to water ingress issues between the roof and the side concrete structure.

Original problem area showing leaking flashing baffle.

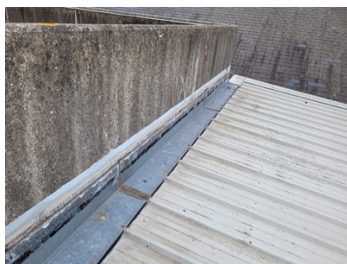
Flashing not sealing between concrete face and over existing roof.

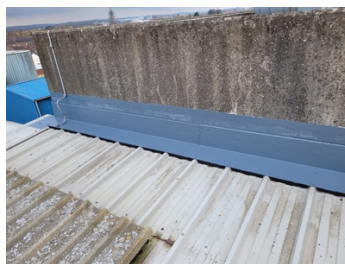
Completed repair using the Belzona 3131 system.

The galvanised steel was cleaned and degreased, prior to having 1 coat of Belzona 3921 General Surface Conditioner applied. 2 coats of Belzona 3131 were applied with a layer of Belzona 9361 reinforcing sheet to give it additional strength.

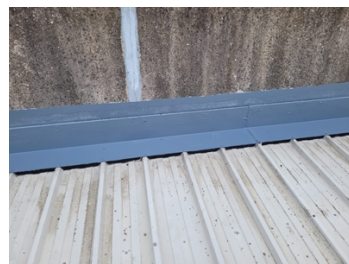
Face on view of the complete Belzona 3131 system repair.
