# Belzona Flange Repair on Circulating Discharge Water Pipe

ID: 10281

**Customer Location:** Chung Nam, South Korea  
**Application Date:** January 2026

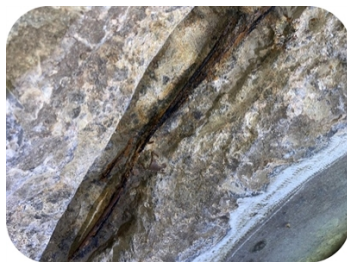
The internal flange coating of the circulating water pipe discharge circulation pipe was found to be damaged and delaminated, leading to the development of water channels beneath the coating layer. This deterioration compromised the integrity and protective performance of the coating system, exposing the substrate to potential corrosion and further degradation.

Damage on the flange of circulating water pipe discharge circulation pipe

Following surface preparation, the deteriorated and uneven areas were rebuilt directly on site using Belzona 1311 (Ceramic R-Metal) to restore the original surface profile and integrity of the affected sections. After the rebuilding material had fully cured, two coats of Belzona 5831 (ST-Barrier) were applied. The completed coating system provided protection against water ingress, erosion, and corrosion while extending the service life of the circulation pipe without requiring component replacement.
