# Belzona Restores Damaged Bucket Elevator Conveyor Belt at a Cement Plant

ID: 10328

Application: SHM-Solids Handling Machinery

Customer Location: Teresa, Rizal, Philippines

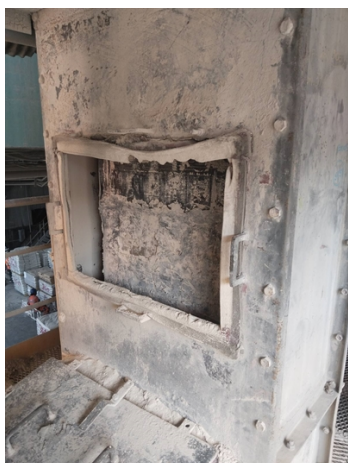
The bucket elevator conveyor belt suffered severe rubber damage due to continuous service, compromising its structural integrity and increasing the risk of sudden failure and unplanned production downtime. The deteriorated section required immediate restoration to maintain safe and reliable operation, eliminate the need for immediate belt replacement, and allow the equipment to be returned to service within the scheduled maintenance period.

Rear side of the bucket elevator belt showing severe rubber damage prior to repair.

Loose and damaged rubber was removed before the repair area was thoroughly cleaned and degreased. Belzona 2911 (Elastomer QD Conditioner) was applied to condition the rubber substrate and promote optimum adhesion. Belzona 2221 (MP Fluid Elastomer)

was then applied together with Belzona 9341 Reinforcement Sheet to restore the structural integrity of the damaged belt. The repair profile was rebuilt using Belzona 2211 (MP Hi-Build Elastomer), followed by the application of Belzona 2131 (D & A Fluid Elastomer) as the final protective topcoat, completing the repair and preparing the belt for return to service.

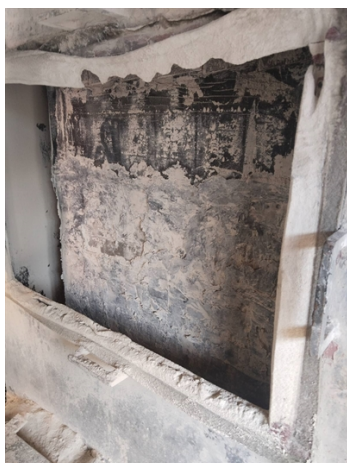
Close-up of the damaged bucket elevator belt showing severe rubber deterioration and material loss prior to repair.

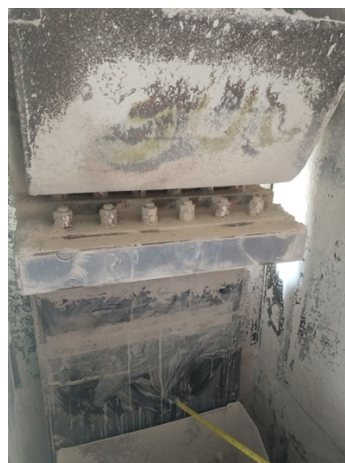
Front view of the bucket elevator belt showing the corresponding repair location.

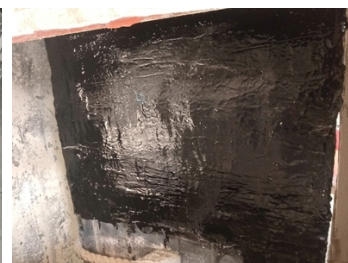
Completed Belzona repair restoring the damaged bucket elevator belt for return to service.
