I.D. FAN SHAFT REPAIRED IN SITU WITH BELZONA

ID: 1034

Customer Location: Power plant, Bulgaria
Application Date: May 2006

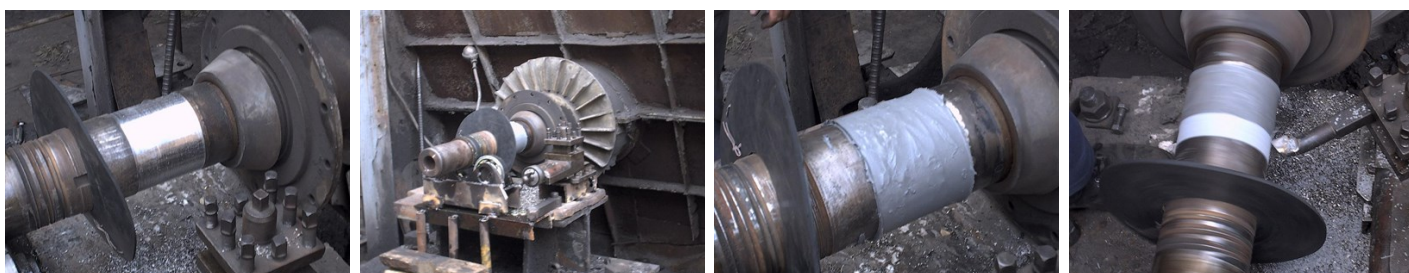
Shaft damaged at bearing location by seized bearing.

- * Damaged area of the shaft undercut ,
- * All machining and application work carried out on site by using fan rotation and small hand lathe ,
- * Belzona® 1111 applied ,
- * Machining to the final diameter ,

Application was carried out in accordance with Belzona Know-How System Leaflet MPT-1. The journal was prepared and machined in situ using the draft of the gases to rotate the shaft. Simple small lathe was mounted to machine the area to desired diameter.

Belzona used to rebuild the original dimensions of the shaft without dismatling the fan. Belzona returned the equipment in service with minimal production down time. This procedure has become standard for emergency shaft repairs in the plant.
