BELZONA® REPAIR OF DIESEL ENGINE CASING

ID: 1054

Customer Location: Dockyard, Bulgaria

Yanmar diesel engine of electrical generator from vessel

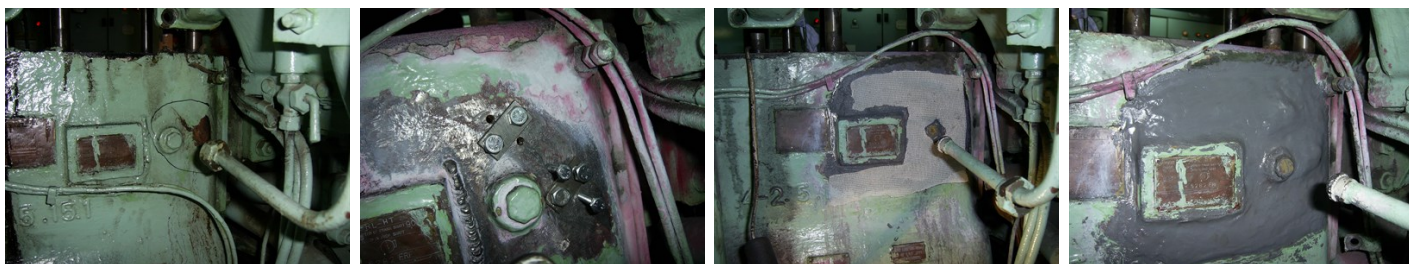
Damaged casing of the engine with leakage of cooling water from the water jacket.

* View of the cracked casing , * Crack terminated and metal reinforcement straps fixed , * Application of Belzona® 1111 with additional Belzona® 9341 (Reinforcement Tape) in progress , * View of the completed application ,

The conventional repair by welding was done previously without success. The welds cracked soon due to the induced stresses and brittle condition of the engine casing. All conventional repair companies refused any repair. After application and test runnings of the engine the customer was fully satisfied with the results. Belzona solution was time and cost effective and saved the customer replacement costs.

Application was carried out in accordance with Belzona Know-How Leaflet ENC-1. The internal surface of the casing was additionally protected with a coat of Belzona® 1392.
