BELZONA® REPAIR OF DIESEL ENGINE CASING

ID: 1054

Industry: Marine

Yanmar diesel engine of electrical generator from vessel

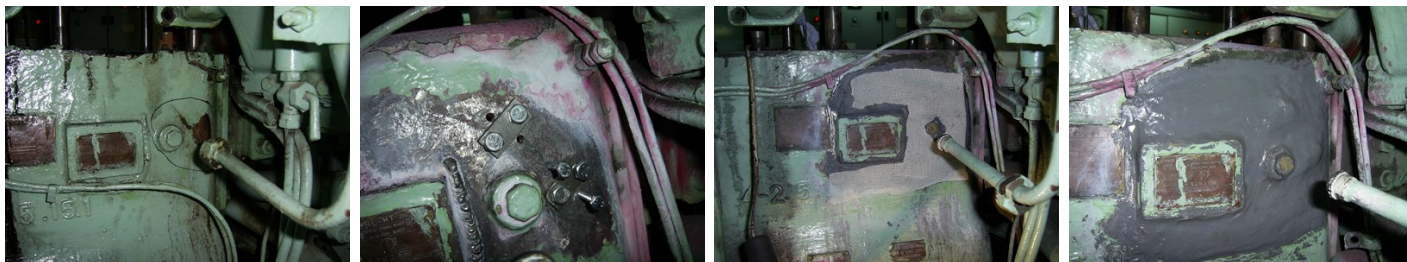
Damaged casing of the engine with leakage of cooling water from the water jacket.

* View of the cracked casing , * Crack terminated and metal reinforcement straps fixed , * Application of Belzona® 1111 with additional Belzona® 9341 (Reinforcement Tape) in progress , * View of the completed application ,

The conventional repair by welding was done previously without success. The welds cracked soon due to the induced stresses and brittle condition of the engine casing. All conventional repair companies refused any repair. After application and test runnings of the engine the customer was fully satisfied with the results. Belzona solution was time and cost effective and saved the customer replacement costs.

Application was carried out in accordance with Belzona Know-How Leaflet ENC-1. The internal surface of the casing was additionally protected with a coat of Belzona® 1392.
