# BELZONA GIVES LIFE TO PUMP

ID: 1096

Industry: Power  
Application: ENC-Engines and Casings  
Substrate: Cast iron  
Products: Belzona® 1111 (Super Metal)

Customer Location: Power Plant, Russia  
Application Date: June, 1998

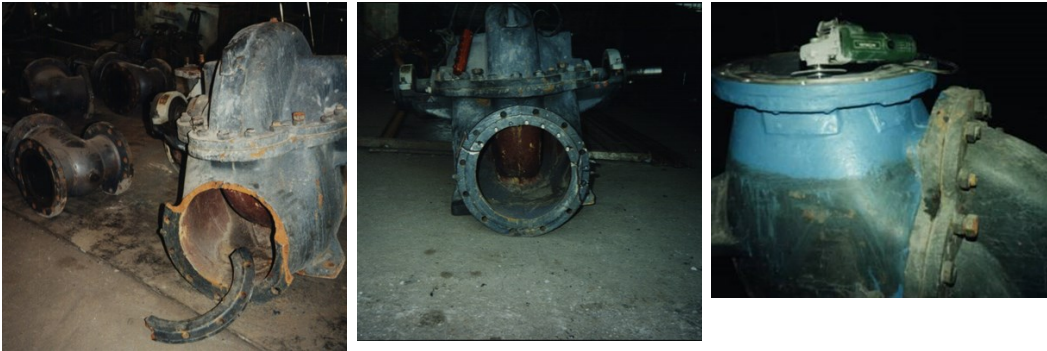
Due to inaccurate assembling of suction pipe and pressure pipe both suction and pressure flanges were torn off the pump body.

\* Pump lost its flanges , \* Flanges are in place again with Belzona® 1111 , \* The pump is restored ,

Flanges were rebuilt from pieces. All cracks in the pump casing were detected, cut out and fixed in accordance with Belzona Know-How System Leaflet ENC-1. Steel reinforcing plates were made. Flanges and reinforcing plates were fixed with Belzona® 1111 and secured with screws.

Repair work took 36 hours. Pressure testing of the pump at test bench showed full impermeability. Put back into operation and worked more than 2 years until planned replacement. With Belzona solution the customer avoided serious losses from new pump purchase and long downtime. Full repair cost only 10% of new pump price.
