BELZONA BELT REPAIR KEEPS MINE PRODUCING

ID: 1229

Customer Location: Mine, Central Missouri

Application: SHM-Solids Handling Machinery

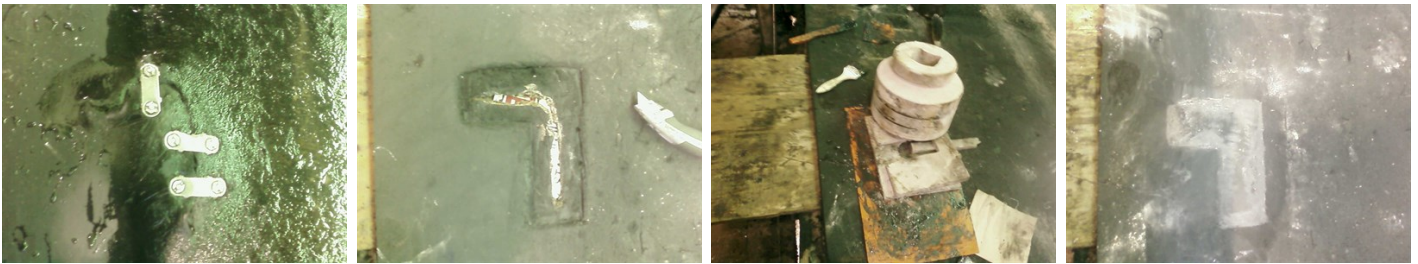
A large rock found its way between the drive roller & the belt, resulting in extensive damage to belt. Minimizing downtime was crucial!

* Attempts to prevent belt from tearing further Belt cleaned and undercut Former with weights in place to form repair smooth and flush with belt surface Repair completed ,

Application was carried out in accordance with Belzona Know-How System Leaflet SHM-1. The belt was cleaned, degreased, and undercut 1/4" x 3" wide on all sides of damaged area. Reinforcement tape was embedded in the Belzona® 2211 for additional strength.
