# BELZONA REPAIR TO DIAPHRAGMS IN STEAM TURBINE

ID: 126

Customer Location: Power Plant in Indianapolis  
Application Date: February 1995

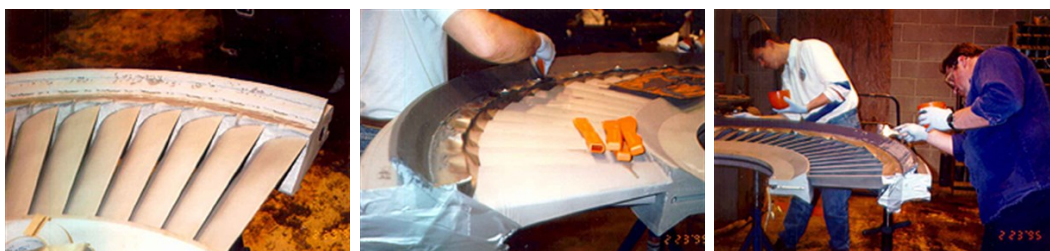
Severe erosion/ corrosion of the turbine diaphragms in the the latter stages of the low pressure side of the steam turbine. This had been caused by many years exposure to saturated steam and had resulted in a decrease in efficiency in the turbine.

- \* Erosion damage on the diaphragm ,
- \* Application of Belzona® 1311 to restore profiles ,
- \* Application of Belzona® 1391 underway ,

Modified versions of Belzona Know-How Leaflets CEP-5 and CEP-3. Belzona® 1311 was used to rebuild the damaged areas. Sites rebuilt were then treated with two coats of Belzona® 1391.
