CAVITATION DAMAGED IMPELLER REPAIRED WITH BELZONA

ID: 1260

Customer Location: Water Treatment Plant, Virginia.
Application Date: April 2008

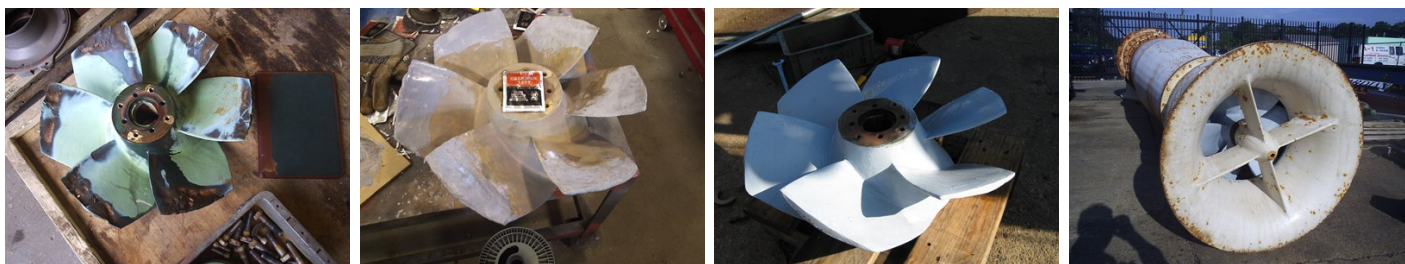
Impeller was damaged by cavitation leading to vibration in the pump. NSF approved products required.

- * Impeller showing Cavitation Damage ,
- * Impeller repaired with Belzona® 1221 ,
- * Impeller coated with Belzona® 1341N ,
- * Impeller installed into pump and ready for service ,

Application was carried out in accordance with Belzona Know How System Leaflet CEP-3 & 5.

New impeller cost \$12,000 - \$14,000 with a 24 week lead time. Past experience proved brazing the bronze could lead to future metal failures. The Belzona repair is quick, low cost and effective solution. This application has been two years of service and is performing with out flaw.
