PROPELLER CAVITATION DAMAGE REPAIRED WITH BELZONA

ID: 1424

Bronze propeller of bulk carrier.

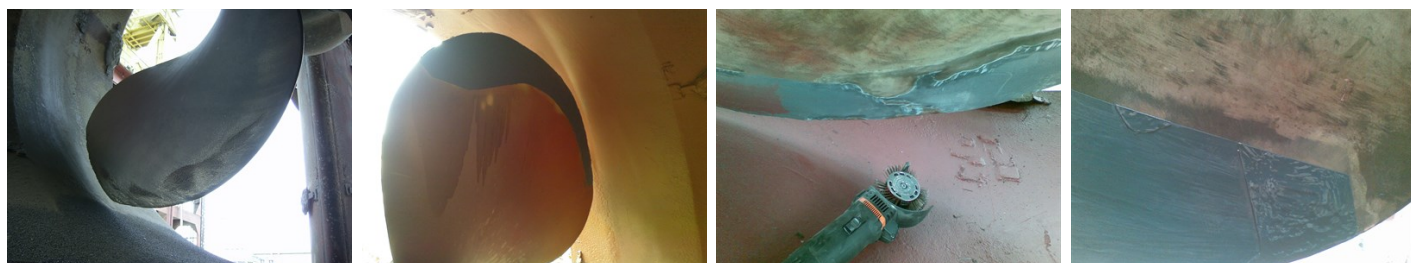
The cavitation damage close to the edges of the bronze propeller caused lower hydrodynamic efficiency and propulsion capabilities of the vessel.

- * The general view of cavitation damages after grit blasting ,
- * After rebuild with Belzona® 1311 two coats of Belzona® 1321 were applied ,
- * Inspection one year after the repair found some small mostly mechanical damage that were prepared by Bristle blasting ,
- * The damaged areas were corrected with Belzona® 1321 ,

The rebuild of cavitation damages by conventional welding and remachining were considered as too time consuming and required special skills to restore significant metal losses. The Belzona repair, in spite of being sacrificial, was chosen as more cost effective and time saving. After 1 year minor damage, mainly mechanical was found and locally repaired with further Belzona using an MBX
