BELZONA REPAIRS TRANSFORMER FLANGE OIL LEAK

ID: 1491

Flanged pipe connections on transformer flange at the major power company.

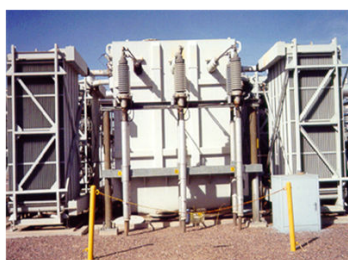
Oil leaks raised maintenance, EPA and safety concerns. Replacement of gaskets would require shut-down and dismantling of equipment.

- * 1. Oil leak area of transformer ,
- * 2. Seal with Belzona 1221, then pour Belzona 2221 encapsulated the flange ,
- * 3. Application completed ,
