BELZONA® 2211 SEALS OIL LEAKS ON SWITCH RELAYS

ID: 151

Customer Location: Electricity Distribution, Western Australia

Earth bushings on an oil filled switching unit

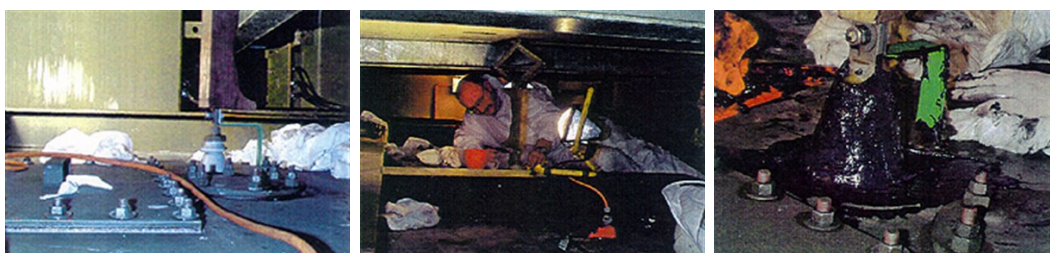
Up to five litres of oil per day were leaking through the bushings. Full repairs, working inside the reactor were deemed to contravene their Duty of Care, so alternatives were sought.

- * One of the leaking earth bushings ,
- * Work underway on the bushing (Note wedge in place to stem leak.) ,
- * Application of Belzona® 2211 complete ,

Application was carried out by encapsulating and sealing the leaking bushing to the surrounding metal. A jack between roof and bushing top was used to stem leak by compressing against cork gasket while the Belzona application is completed.
