BELZONA® 2211 SEALS OIL LEAKS ON SWITCH RELAYS

ID: 151

Customer Location: Electricity Distribution, Western Australia

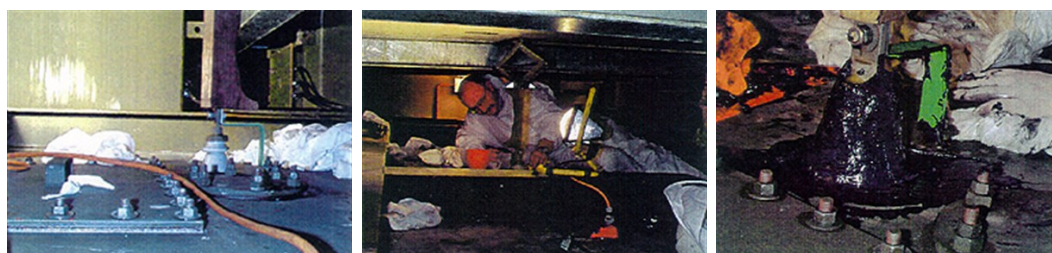
Up to five litres of oil per day were leaking through the bushings. Full repairs, working inside the reactor were deemed to contravene their Duty of Care, so alternatives were sought.

- * One of the leaking earth bushings ,
- * Work underway on the bushing (Note wedge in place to stem leak.) ,
- * Application of Belzona® 2211 complete ,

Application was carried out by encapsulating and sealing the leaking bushing to the surrounding metal. A jack between roof and bushing top was used to stem leak by compressing against cork gasket while the Belzona application is completed.
