BELZONA PUMP REPAIR PROVIDES OVER TEN YEARS OF UNINTERRUPTED SERVICE

Application: *CEP-Centrifugal Pumps*

Customer Location: *Paper Company in Georgia*

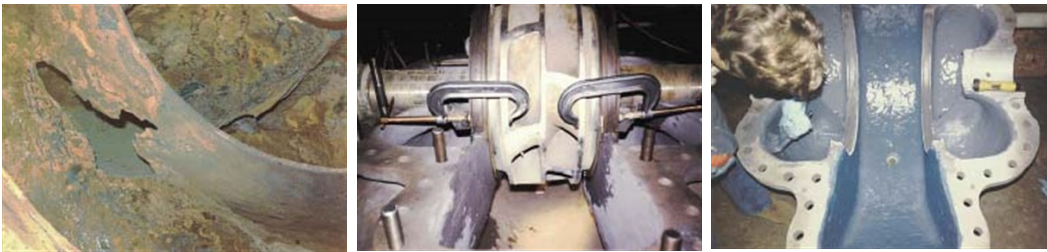
Pump suffered from erosion/corrosion and was completely destroyed after four years of operation

- * Severe damage ,
- * The wear ring seats rebuilt, clamps help ensure proper alignment ,
- * Belzona® 1321 (Ceramic S Metal) coating ,

The application was carried out in accordance with Belzona Know-How Leaflets CEP-1, CEP-2 and CEP-3.

Pump replacement cost is \$60,000.00. Cost of Belzona repair: \$9,300.00. After more than ten years of uninterrupted service, the pump is still in use and twice required only minor touch-ups. An impressive savings of three pump replacements.
