# BELZONA PUMP REPAIR PROVIDES OVER TEN YEARS OF UNINTERRUPTED SERVICE

Industry: *Pulp & Paper*  
Application: *CEP-Centrifugal Pumps*  
Substrate: *Cast iron*  
Products: *\* Belzona® 1311 (Ceramic R Metal) ,*  
*\* Belzona® 1321 (Ceramic S Metal) ,*

Customer Location: *Paper Company in Georgia*  
Application Date: *November 1986*

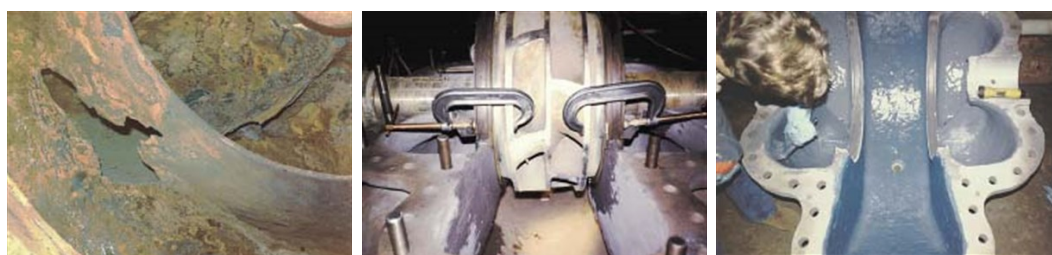
*Pump suffered from erosion/corrosion and was completely destroyed after four years of operation*

- \* Severe damage ,
- \* The wear ring seats rebuilt, clamps help ensure proper alignment ,
- \* Belzona® 1321 (Ceramic S Metal) coating ,

The application was carried out in accordance with Belzona Know-How Leaflets CEP-1, CEP-2 and CEP-3.

Pump replacement cost is \$60,000.00. Cost of Belzona repair: \$9,300.00. After more than ten years of uninterrupted service, the pump is still in use and twice required only minor touch-ups. An impressive savings of three pump replacements.
