BELZONA IDEAL SOLUTION FOR DAMAGED CONVEYOR BELT

ID: 3125

Customer Location: *Paper Mill, São Paulo, Brazil*

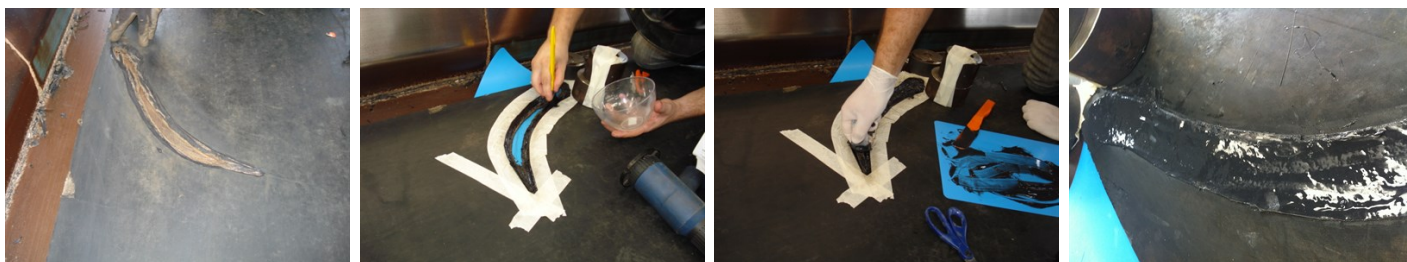
Photograph Descriptions

The fork lift driver caught the conveyor belt while he was loading the paper, stopping the process and tearing the belt.

- * Conveyor belt damage ,
- * Preparation and conditioning with Belzona® 2911 ,
- * Belzona® 2311 being applied and incorporating Belzona® 9341 (Reinforcement Tape) ,
- * Job done ,

The application was carried out in accordance with Belzona Know-How system Leaflet SHM-1. Top cover was cut back before repairing with Belzona® 2311 incorporating Belzona® 9341 (Reinforcement Tape).
