BELZONA DIESEL ENGINE BLOCK RESTORED

ID: 32

Industry: *Marine*
Application: *ENC-Engines and Casings*
Substrate: *Cast steel*
Products: ** Belzona® 1111 (Super Metal) ,*

Customer Location: *Ship Repair Company in Florida*
Application Date: *August 1995*

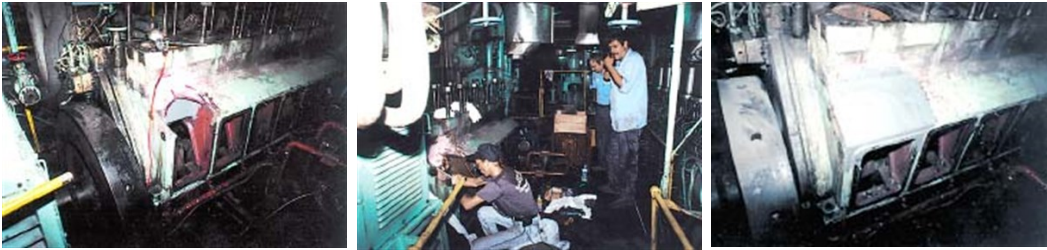
Connecting rod went through the side of the casing, severely damaging the engine block

* Damaged engine block In the engine room, work in progress The finished repair ,

The application was carried out in accordance with a modified version of Belzona Know-How Leaflet ENC-1.
