# BELZONA DIESEL ENGINE BLOCK RESTORED

ID: 32

Customer Location: *Ship Repair Company in Florida*  
Application Date: *August 1995*

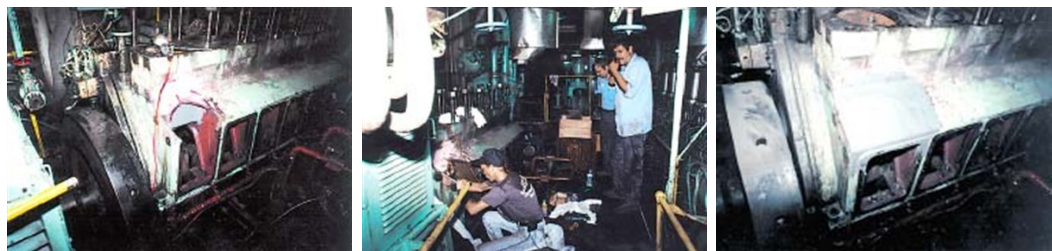
*Connecting rod went through the side of the casing, severely damaging the engine block*

\* Damaged engine block In the engine room, work in progress The finished repair ,

The application was carried out in accordance with a modified version of Belzona Know-How Leaflet ENC-1.

Replacement cost of the engine block is greater than \$50,000. The total cost of the repair including labor and materials was \$5,180. The vessel's owner saved over \$45,000.
