# CAVITATION DAMAGE TO THIS TANKER PROPELLER REPAIRED WITH BELZONA

ID: 338

Customer Location: Oil tanker in Argentina, South America  
Application Date: April 1997

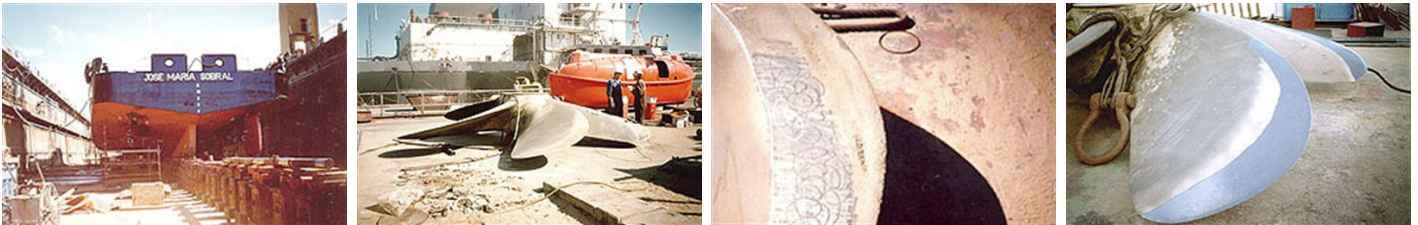
The large difference in pressure on the edges of this bronze propeller caused cavitation bubbles that in turn damaged the metal substrate after imploding onto the surface.

- \* Aft view of the tanker ,
- \* Surface preparation of the bronze propeller ,
- \* Close up view of grinding profile ,
- \* Finished application ,

Cavitation damage to a 12-foot diameter tanker propeller.

The application was carried out in accordance with Belzona Know-How System Leaflet SOS-2.
