# CAVITATION DAMAGE TO THIS TANKER PROPELLER REPAIRED WITH BELZONA

ID: 338

Customer Location: *Oil tanker in Argentina, South America*  
Application Date: *April 1997*

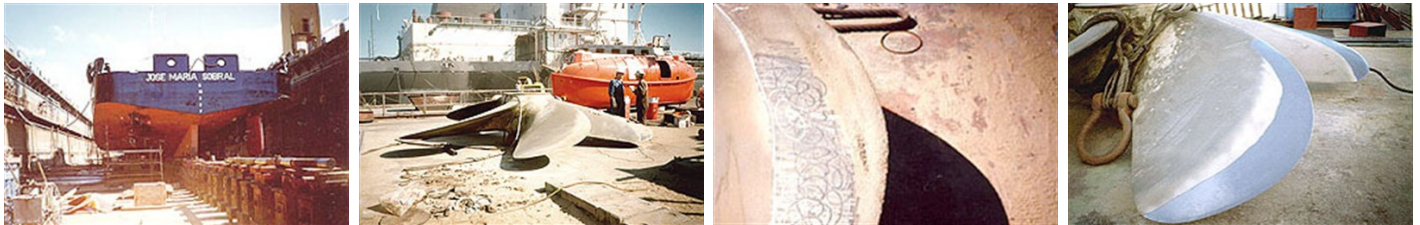
*The large difference in pressure on the edges of this bronze propeller caused cavitation bubbles that in turn damaged the metal substrate after imploding onto the surface.*

- \* Aft view of the tanker ,
- \* Surface preparation of the bronze propeller ,
- \* Close up view of grinding profile ,
- \* Finished application ,

Cavitation damage to a 12-foot diameter tanker propeller.

The application was carried out in accordance with Belzona Know-How System Leaflet SOS-2.
