# BELZONA REPAIRS AND PROTECTS ENGINE BLOCK AND CYLINDER LINERS

ID: 3641

Ship diesel engine block

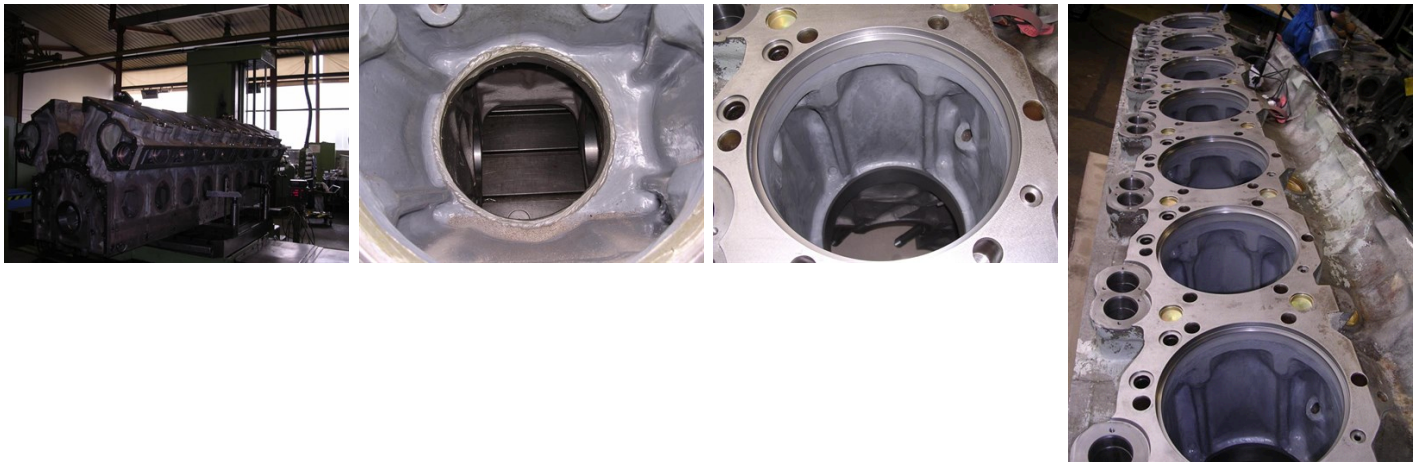
Corrosion and cavitation damage in cooling water area as well as leaking O-ring sealing surfaces.

- \* Diesel engine block prior to repair ,
- \* Close-up of application area ,
- \* Close-up of application area ,
- \* Completed engine block application ,

The repair to the sealing faces was carried out in accordance with Belzona Know-How System Leaflet ENC-5, using machining methods. Areas damaged by corrosion and cavitation were rebuilt with Belzona® 1111, and cooling water areas were fully coated with Belzona® 1391 in accordance with Belzona Know-How System Leaflet ENC-6.
