Rebuilding damaged overhead concrete

ID: 3823

Customer Location: Iron Ore Company, IRAN
Application Date: July 2012

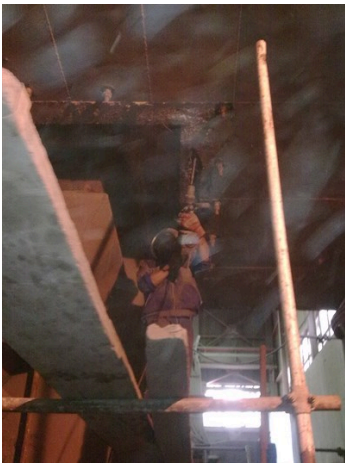
Due to the existence of crack in the concrete structure and ingress of water in the cracks, some area of concrete gets part and the round bars are corroded with expose to water and air.

- * 1. Removing damaged concrete ,
- * 2. Damaged area and showing round bars ,
- * 3. and 4. Completed repair ,
