# Rebuilding damaged overhead concrete

ID: 3823

Customer Location: Iron Ore Company, IRAN  
Application Date: July 2012

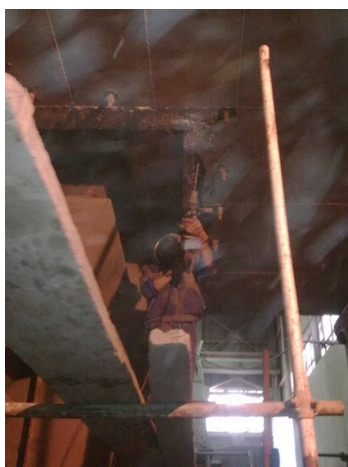
Due to the existence of crack in the concrete structure and ingress of water in the cracks, some area of concrete gets part and the round bars are corroded with expose to water and air.

- \* 1. Removing damaged concrete ,
- \* 2. Damaged area and showing round bars ,
- \* 3. and 4. Completed repair ,

Application carried out in accordance with the Belzona Know-How system leaflet RPA-2 and the selected Belzona 4141 mixed and applied in accordance with the relevant Instruction For Use. Overhead concrete structure has extensive areas of damage created by crack and water leakage and affects the round bars. Application of Belzona 4141 as a lightweight repair system, would protect round bar and reinforce the cracks.
