# BELZONA REPAIRS VENT GAS PIPEWORK

ID: 383

Customer Location: North Sea gas producer  
Application Date: 2003

3" pipespool on gas platform vent system.

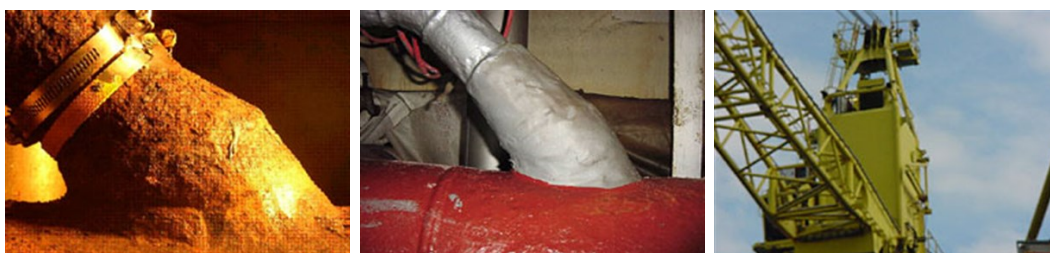
External corrosion had led to severe wall thinning in numerous parts of the pipework. In addition several areas were holed and were being contained with a temporary fix. The welded nature of the pipework would have made replacement of the pipespool impossible as the vent gas pipework forms part of the platform's safety system.

- \* Vent gas pipework showing severe corrosion ,
- \* Completed repair ,
- \* Platform crane's radiator was the site of several other Belzona pipe repairs ,

During a recent platform shutdown the temporary repair was removed and the pipe and surrounding areas were cleaned by grit blasting. Belzona® 1111 was applied to the area and Belzona® 9341 wrapped around the pipe to prevent further deterioration of the corroded area.

This was pressure tested to the design pressure of the system before allowing gas back into the system. All tests were successfully completed.
