# BELZONA REPAIRS VENT GAS PIPEWORK

ID: 383

Customer Location: North Sea gas producer  
Application Date: 2003

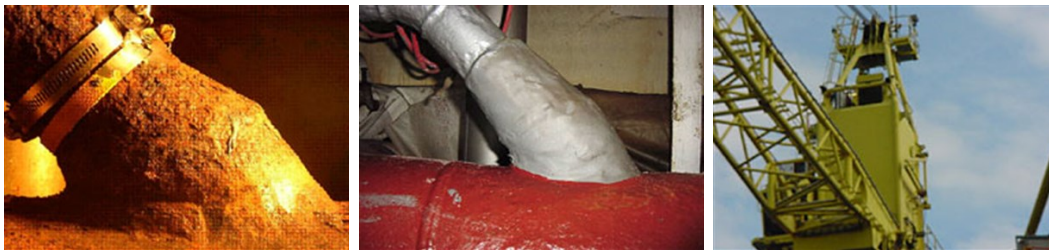
External corrosion had led to severe wall thinning in numerous parts of the pipework. In addition several areas were holed and were being contained with a temporary fix. The welded nature of the pipework would have made replacement of the pipespool impossible as the vent gas pipework forms part of the platform's safety system.

- \* Vent gas pipework showing severe corrosion ,
- \* Completed repair ,
- \* Platform crane's radiator was the site of several other Belzona pipe repairs ,

During a recent platform shutdown the temporary repair was removed and the pipe and surrounding areas were cleaned by grit blasting. Belzona® 1111 was applied to the area and Belzona® 9341 wrapped around the pipe to prevent further deterioration of the corroded area.

This was pressure tested to the design pressure of the system before allowing gas back into the system. All tests were successfully completed.
