THERE'S NOTHING FISHY ABOUT THIS BELZONA REPAIR

ID: 430

Application: ENC-Engines and Casings

Customer Location: Fishing boat

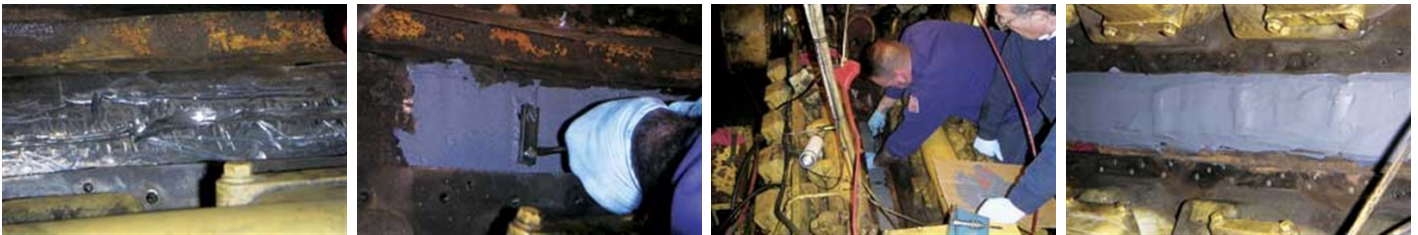
Cooling water froze due to lack of anti-freeze causing the engine block to crack.

- * Engine block after surface prep. ,
- * Belzona® 1111 applied. Metal bars are used to stabilize crack. ,
- * Installing metal bars. ,
- * More Belzona® 1111 applied to cover and protect the metal bars. Job completed. ,

Cracked engine block

The application was carried out in accordance with Belzona Know-How System Leaflet ENC-1.

Weld repairs were rejected due to concerns about heat stress. Quick turn around was important due to lost production while boat was in port.
