# THERE'S NOTHING FISHY ABOUT THIS BELZONA REPAIR

Application: ENC-Engines and Casings

Customer Location: Fishing boat

Cracked engine block

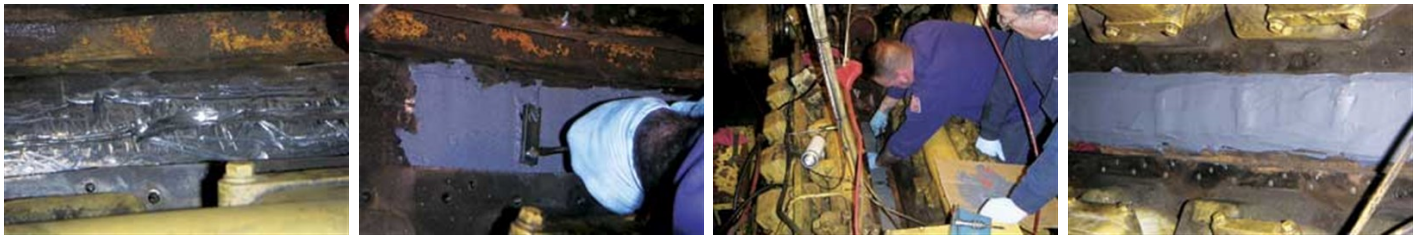
Cooling water froze due to lack of anti-freeze causing the engine block to crack.

- \* Engine block after surface prep. ,
- \* Belzona® 1111 applied. Metal bars are used to stabilize crack. ,
- \* Installing metal bars. ,
- \* More Belzona® 1111 applied to cover and protect the metal bars. Job completed. ,

Weld repairs were rejected due to concerns about heat stress. Quick turn around was important due to lost production while boat was in port.
