BELZONA REPAIRS BROKEN HYDRO ELECTRIC TURBINE RUNNER

ID: 4674

Customer Location: Hydro Electric Plant, USA

Application Date: May, 2007

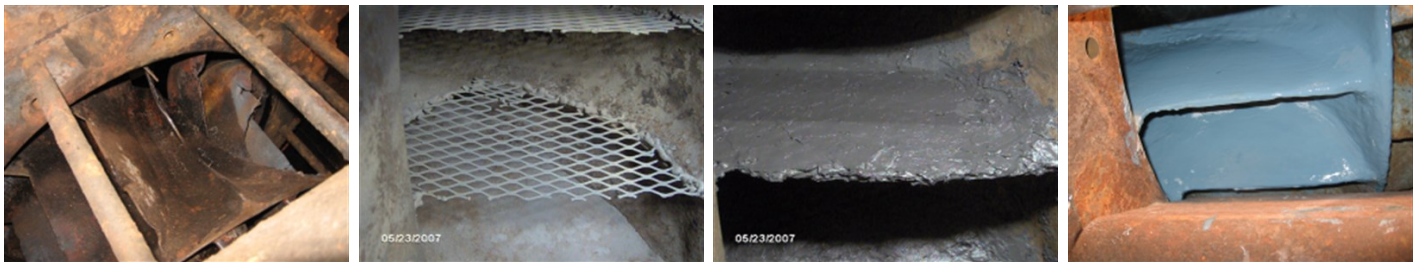
Loss of balance and horsepower.

* Broken runner blade Expanded metal tack welded Blades rebuilt with Belzona® 1311 Completed application after coating runner ,

Wicket gate came loose and fell into turbine breaking three blades on runner.

Application was carried out in accordance with the Belzona Know-How System Leaflets CEP-1 & CEP-3. Expanded metal was tack welded in place before rebuilding with Belzona® 1311. Complete runner was coated with Belzona® 1311 and Belzona® 1341 was applied on top to improve fluid flow efficiency.
