BELZONA REINFLATES FENDER

ID: 4806

Industry: Marine
Application: SOS-Ships and Offshore Structures

Customer Location: Dredging company, Abu Dhabi, U.A.E.
Application Date: October 2013

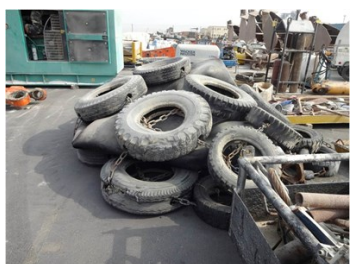
Although wrapped with tyres on chains to help protection, the fenders were in need of a full service or replacement. Punctures had deflated the fenders rendering them useless.

- * Initial inspection of deflated fender ,
- * Stitching of punctures ,
- * Application of Belzona 2111 incorporating ,
- * Reinforcement tape Finished application ,
