BELZONA REPAIRS NEW FLOATING HOSE SECTION DAMAGED IN TRANSIT

ID: 4818

Customer Location: Oil company, North Sea, UK
Application Date: November 2011

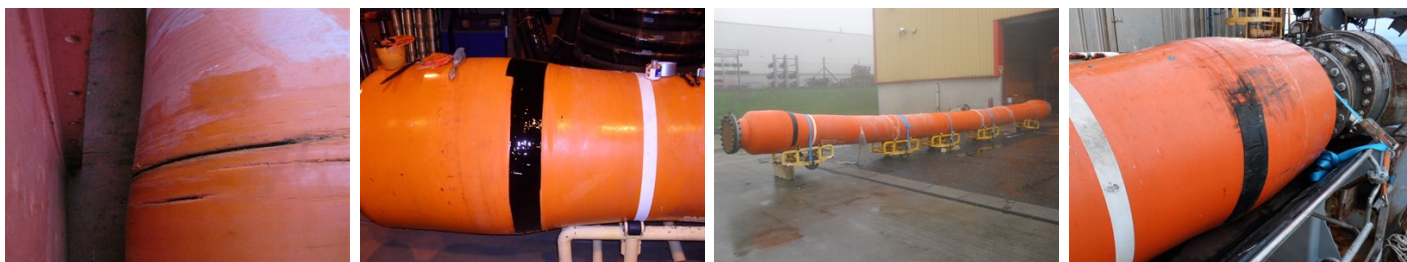
Hose had been damaged in transit as a result of its fastenings coming loose. The hose had rubbed against its container frame.

* 1. 15mm deep cuts in the floating hose cover 2. Application of reinforced system of Belzona 2211 3. Completed Belzona repair 4. Inspection of the hose 2 years later showing the Belzona application still in service ,

Application was carried out in accordance with Belzona System Leaflet SOS-12. The surface of the hose was roughened prior to application of Belzona 2911 (QD Conditioner) followed by a reinforced system of Belzona 2211 to the damaged areas.
