REPAIR OF MOTOR BLOCK OF 789 MINING TRUCK

ID: 4868

Customer Location: *Mine, Chile*
Application Date: *January 2005*

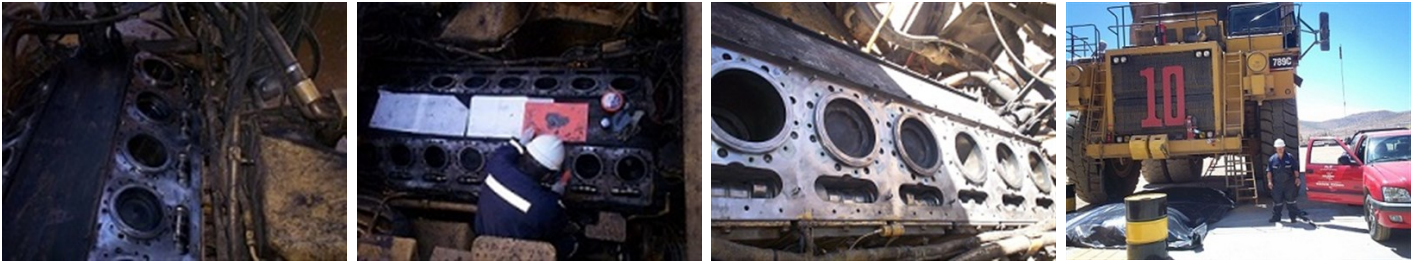
The engine was corroded and presented a problem in the filtration area where water flows from the engine block

- * Damaged engine block ,
- * Application of Belzona 1111 ,
- * Engine block repaired with Belzona 1111 ,
- * Repaired mining truck 789 ,

The damaged area was cleaned, and heat was applied to eliminate oil residue. Next, the area was roughened with sand paper and Belzona 1111 was applied to the prepared surface.
