# BELZONA RESTORES DAMAGED CLUTCH ON DREDGER

ID: 4971

Customer Location: Gravel pit, Croatia  
Application Date: April 2013

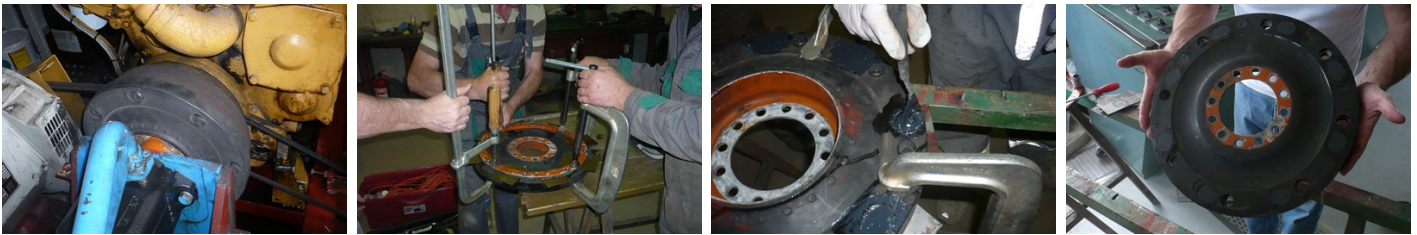
Rubberized clutch suffered damage during operation of the engine. The holes became deformed and the clutch was no longer performing as needed.

- \* Damaged clutch in its original position ,
- \* Metal plates treated with Belzona 9411 and fastened to seal one side of every hole ,
- \* Filling previously prepared and conditioned holes with Belzona 2211 ,
- \* Application completed. Old holes sealed and new ones drilled ,

Application was carried out in accordance with a modified version of Belzona System Leaflet SHM-9. Metal plates treated with Belzona 9411 (Release Agent) were used to form the Belzona Elastomer. Damaged holes were reformed with Belzona Elastomer before being re-drilled in new locations.
