BELZONA REBUILDS DAMAGED PUMP FLANGE

ID: 5193

Industry: Mining & Quarrying

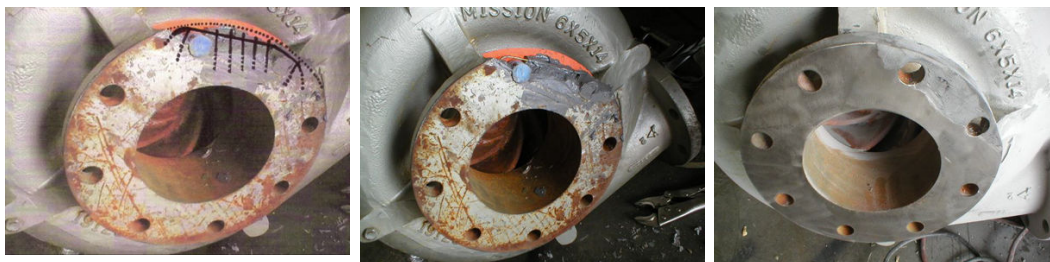
The cast iron pump casing had fallen off a pallet breaking part of the flange.

- * Diagram showing support cage fabricated for the damaged area ,
- * Rebuilding in progress ,
- * Rebuilt flange ,

Broken flange on pump

After tapping a number of holes along the broken flange edge, a reinforcement cage was bonded into place around the edge using a welding rod to provide some structural integrity to the area to be rebuilt. Once in place the various pieces were tack welded together.
