BELZONA REPAIRS ROOF LEAK

ID: 5259

Customer Location: Washington, USA
Application Date: 1984

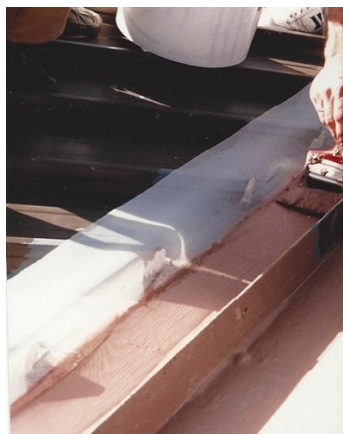
Continual ice build up in the valley forced water under the roof panels due to poor roof design, causing leaks. Someone decided to remove the ice with an ax, causing holes and more leaks.

- * Valley flashing showing ax holes ,
- * Brushing on Belzona 3921 ,
- * First coat of Belzona 3111 with reinforcing sheet ,
- * Completed application ,

The flashing was properly cleaned and abraded. Belzona 3921 was brushed on followed by two coats of Belzona 3111 being applied

with Belzona 9311, which was laid onto the substrate. The application was carried out in accordance with Belzona Know-How System Leaflet RPA-8.
