BELZONA REPAIRS ENGINE BLOCK

ID: 5264

Industry: *General Industry*
Application: *ENC-Engines and Casings*
Substrate: *Cast Iron*
Products: ** Belzona 1111 (Super Metal) ,*

Customer Location: *Seward, AK, USA*
Application Date: *1981*

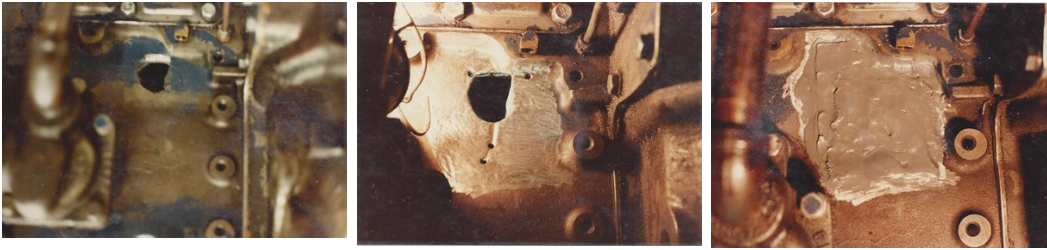
A hole in the engine block allowed the oil to leak out.

- * The engine block showing the hole ,
- * The cracks have been stabilized by drilling the extremities ,
- * A plate was bonded over the hole using Belzona 1111 ,

A broken connecting rod went through the block. The owner replaced the rod but did not know what to do about the hole. Belzona repaired the hole, solving the problem for the owner.

After proper surface preparation the application was carried out in accordance with Belzona Know-How System Leaflet ENC-1.
