BELZONA REPAIRS PROFILE OF HYDROELECTRIC DAM

ID: 5285

Customer Location: Washington, USA
Application Date: October 2012

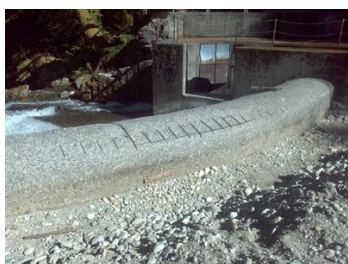
The profile of a small hydroelectric dam became worn, exposing reinforcing bar, which was caused by damage from VW sized boulders tumbling into and over the face of dam during spring runoff. The client was concerned about maintaining the integrity of the small hydroelectric dam and restoring the original profile.

- * Dam (ogee) profile before repairs ,
- * Several pallets of Belzona 4111 on site ,
- * Dam repairs underway - note templates & mixer ,
- * Completed application ,
