BELZONA REPAIRS A 75-YEAR OLD VALVE FLAPPER

ID: 5350

Hydro Dam Check Valve Flapper

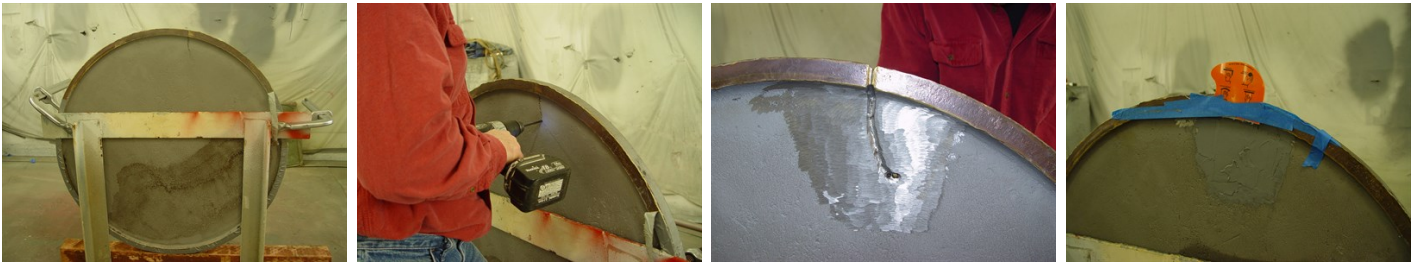
Cast Iron flapper disc had developed a crack. The check valve was 75 years old.

- * Flapper disc showing the crack at 1 o'clock. ,
- * Drilling the crack to place studs. ,
- * Area prepared, studs in place. ,
- * Belzona 1111 applied with reinforcement sheet, applicator taped in place to smooth the seal area. ,

The application was carried out in accordance with Belzona System Leaflet ENC-1. The plastic applicator was used to form the face in the seal area.

Because the check valve was 75 years old there was no replacement available. Fabricating a new flapper from steel was just too expensive.
