BELZONA REPAIRS A CRACKED ENGINE BLOCK

ID: 5366

John Deer engine block.

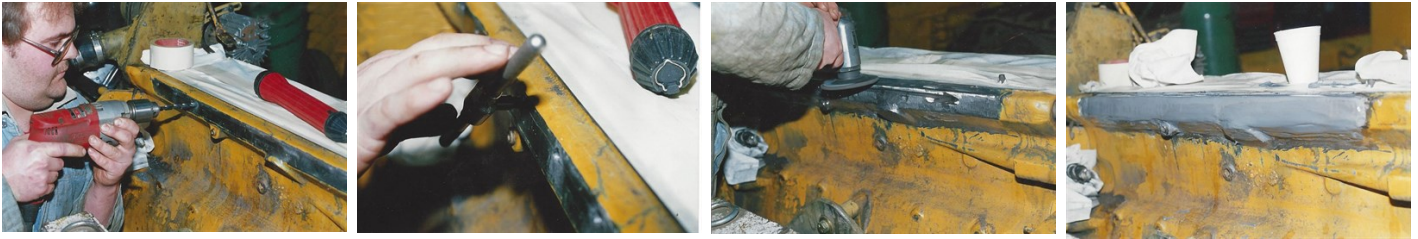
Engine block cracked by freezing water.

- * Drilling holes along crack ,
- * Threading holes ,
- * Studs installed, grinding surface ,
- * Reinforced Belzona 1111 applied to seal the crack ,

The application was carried out in accordance with Belzona Know-How System Leaflet ENC-1.

The only alternative was to replace the block. Instead, \$50.00 of Belzona 1111 was used to solve the problem.
