BELZONA REPAIRS DRILLING MACHINE THREAD

ID: 5411

Customer Location: *Lynchburg, VA, USA*
Application Date: *July 2014*

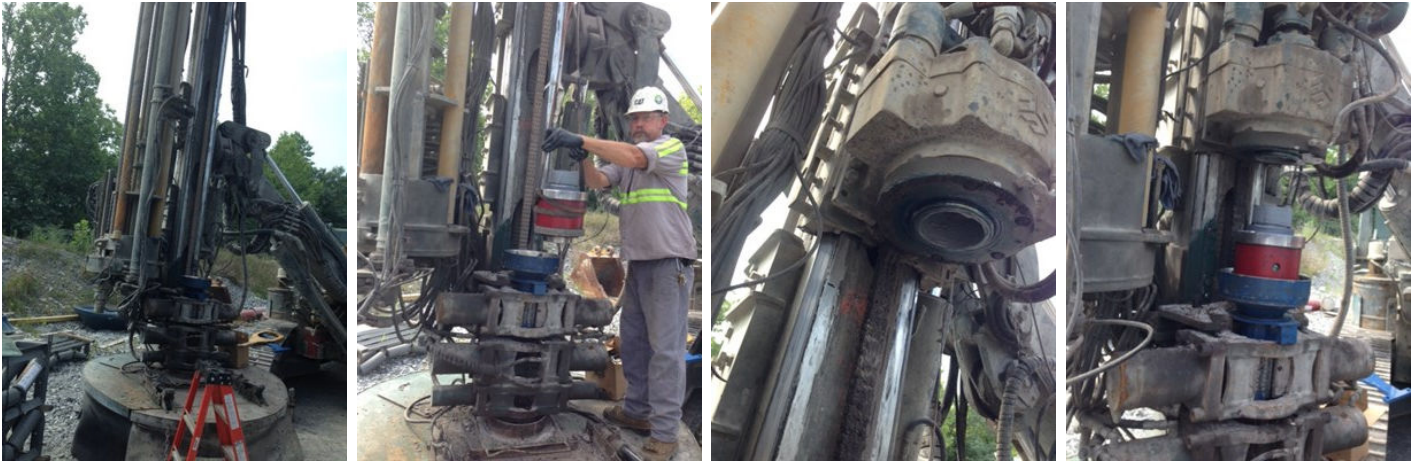
Photograph Descriptions

Worn threads on drilling machine would not allow the drill to seal properly, allowing water to leak and lose water pressure.

- * Overview of the drill ,
- * Male thread being placed underneath the female piece ,
- * Oversized female thread filled with Belzona 1111 ,
- * Belzona 1111 applied on male thread prior to placing both pieces together to complete the application ,

Threads on drilling machine were worn.

The threads were cleaned, using a suitable cleaner/degreaser and a wire brush on the female threads. A release agent was used on a new male thread piece. Belzona 1111 was mixed and applied to both male and female threads. The new piece was screwed into the worn female piece. The excess was wiped off and it was allowed to cure overnight. The new piece was removed in the morning, inspected and then screwed back and sealed. The drill has been constantly used for 2 months now and there are no signs of leakage.
