# BELZONA REPAIR OF A SAND PUMP INCREASES SERVICE LIFE

ID: 5426

Customer Location: South Louisiana, USA  
Application Date: February 2014

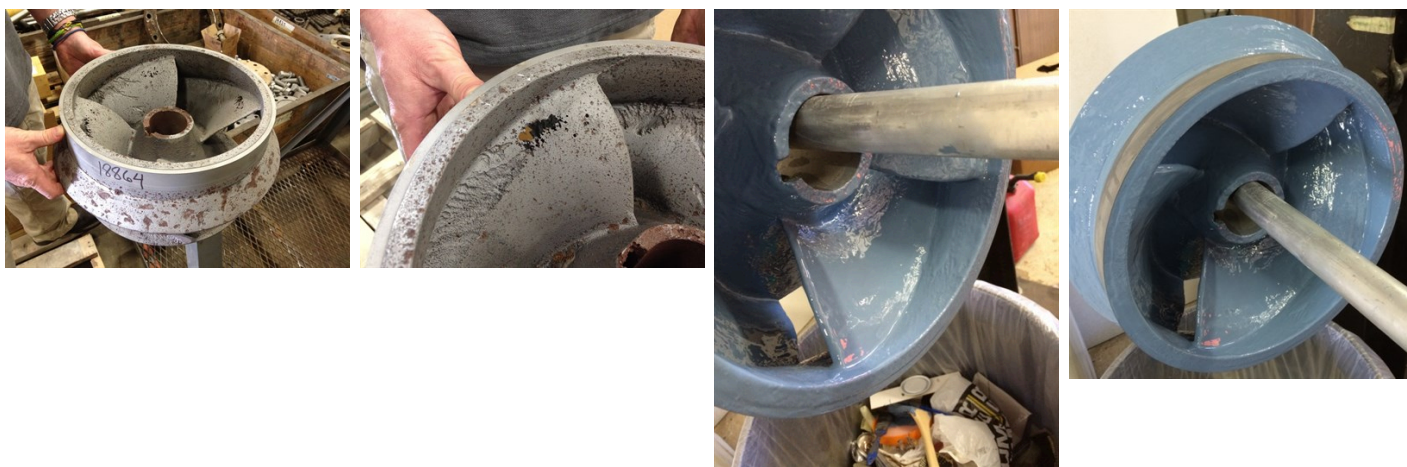
Due to high sand content in the water being pumped, impeller had holes and other areas of metal loss.

- \* Impeller upon arrival ,
- \* Holes and other visible damage to be repaired ,
- \* Coated vanes ,
- \* Impeller finished and ready to be re-installed in pump ,

Metal loss and holes in impeller vanes; pitting on outside of impeller.

The application was carried out in accordance with a modified version of Belzona Know-How System Leaflets CEP-1 and FBC-2
