Belzona Pump Repair - From A to Z

ID: 543

Customer Location: Water Plant - Egypt
Application Date: April 2005

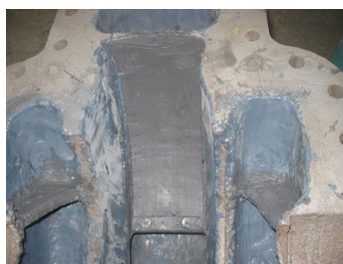
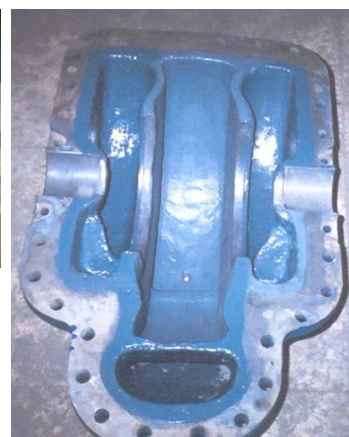
The pump casing, cut water, straighteners, wear ring and gland housing were all suffering from erosion-corrosion. Also, there was a long crack on the cut water.

- * General view of the pump before repair. ,
- * The pump after surface preparation. ,
- * Crack of cutwater was repaired and the cutwater and the straighteners were rebuilt. ,
- * Repair complete. Note how the seats and gland housing were perfectly repaired. ,

Application was carried out in accordance with Belzona Know-How System Leaflets CEP-1, CEP-2, CEP-3, CEP-5 and CEP-6.

Belzona repaired everything in the pump - from the casing to the cut water and straighteners, including repairing the wear ring seat
