Offshore repair of a riser pipe

ID: 5462

12" T-pipe on an FPSO.

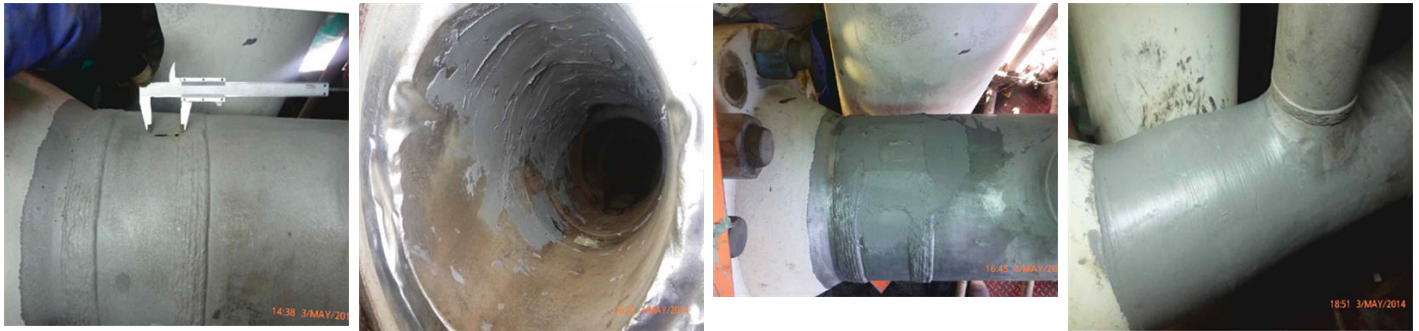
Cavitation near the flange, erosion between flange and T-section. Surface preparation created through-wall defects because of the thin remaining thickness of the pipe at some points.

- * Before repair ,
- * During internal application ,
- * External repair - plate bonding ,
- * Finished repair ,

In this case of emergency, an internal repair has been carried out first with Belzona 1121 in accordance with Belzona Know-How system leaflet VPF-1. Then a plate has been bonded on the through wall defect using the system leaflet VPF-11. To finish the repair, a reinforced wrap has been applied with Belzona 1121 and Belzona 9341. As the customer wanted a compliant repair, a Belzona SuperWrap system was designed and applied atop.
