# BELZONA REPAIRS 8" WATER PIPE/FLANGE

ID: 5478

Customer Location: Anadarko, Oklahoma  
Application Date: October 2014

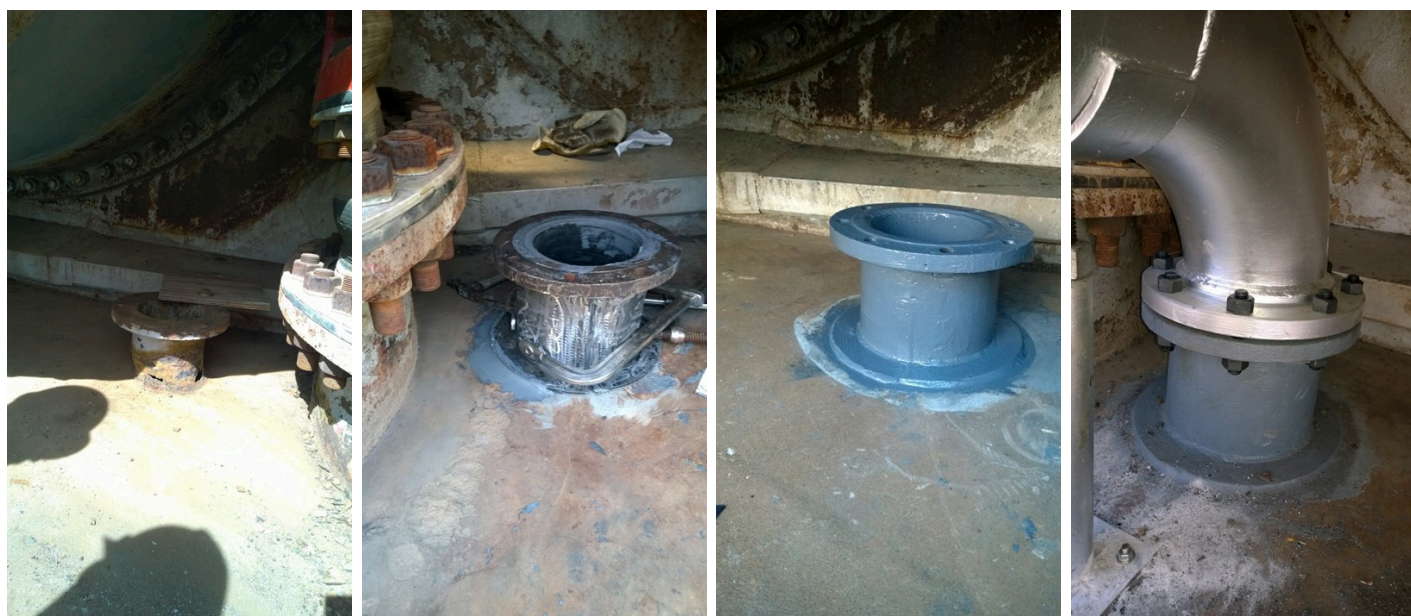
8" pipe had corroded all the way through the pipe in several areas around it. The heat condensers were installed directly above the flange and the pipe that returned cooled water back into the plant. There was not a lot of room to work with and the customer did not know how to seal or repair. They wanted a solution that would prevent the pipe from seperating at the concrete level.

- \* 8" pipe/flange in existing condition ,
- \* Cold bonding process with Belzona 1121 to the interior and exterior sleeve ,
- \* Two coats of Belzona 1321 on interior and exterior ,
- \* Completed application and back in service ,

Corrosion was removed through grinding and the interior sleeve was then cold bonded with Belzona 1121. The voided areas and rough edges were then filled in with Belzona 1121 around the interior sleeve. The exterior sleeve to the 8" pipe and the concrete was cold bonded with Belzona 1121. Two coats of Belzona 1321 were applied on the interior and exterior.
