Belzona Repairs Loose Wear Ring

ID: 555

Customer Location: Power plant - Egypt
Application Date: February, 2003

Wear ring in main cooling water pump

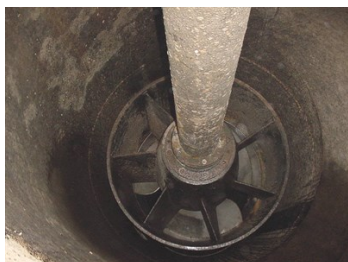
- * General view of the pump ,
- * Corrosion caused wear at the ring ,
- * Application of the first layer of Belzona® 1321 ,
- * Removing excess material after injecting the second layer of Belzona® 1321 ,

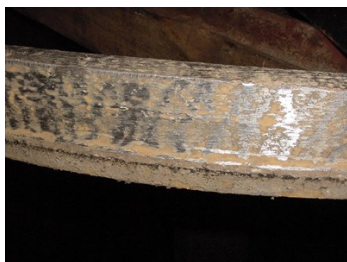
Ring had become loose in its housing.
