Belzona Repairs Loose Wear Ring

ID: 555

Customer Location: Power plant - Egypt
Application Date: February, 2003

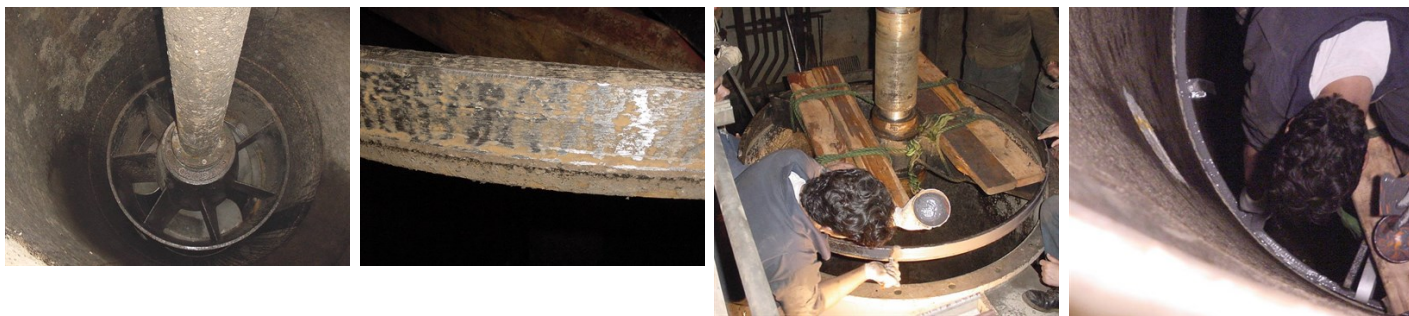
Ring had become loose in its housing.

- * General view of the pump ,
- * Corrosion caused wear at the ring ,
- * Application of the first layer of Belzona® 1321 ,
- * Removing excess material after injecting the second layer of Belzona® 1321 ,

Wear ring in main cooling water pump

Application was carried out in accordance with modified version of Belzona® Know-How System Leaflet CEP-2.
