# Repair of the damaged motorcycle fork cover KTM

ID: 5575

Industry: Transport  
Application: ENC-Engines and Casings  
Substrate: GFRP  
Products: Belzona 1221 (Super E-Metal)

Customer Location: Oraving Slovnaft Team, Slovakia  
Application Date: 2015 January

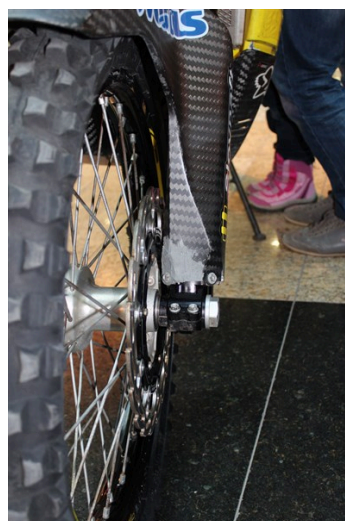
Slovak rider (supported by Belzona products) with escort repair truck - fifth overall bike on the Dakar rally 2015

Repairs in the field conditions

Application was carried out in accordance with Belzona Know-How System Leaflet ENC-1 in field conditions. The cover was dismounted, ragged by steel brush, cleaned and recovered with Belzona 1221 together with Belzona 9341.

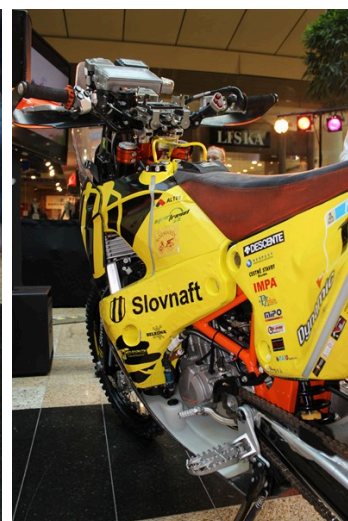
"Emergency" repair of the damaged motorcycle fork cover KTM hold for the all race (photo from after rally promotion show)

Motorcycle KTM - after rally promotion show
