BELZONA REPAIRS DAMAGED GEAR BOX

ID: 569

Customer Location: Petrochemical facility, Egypt
Application Date: October 2003

Service vehicle gear box

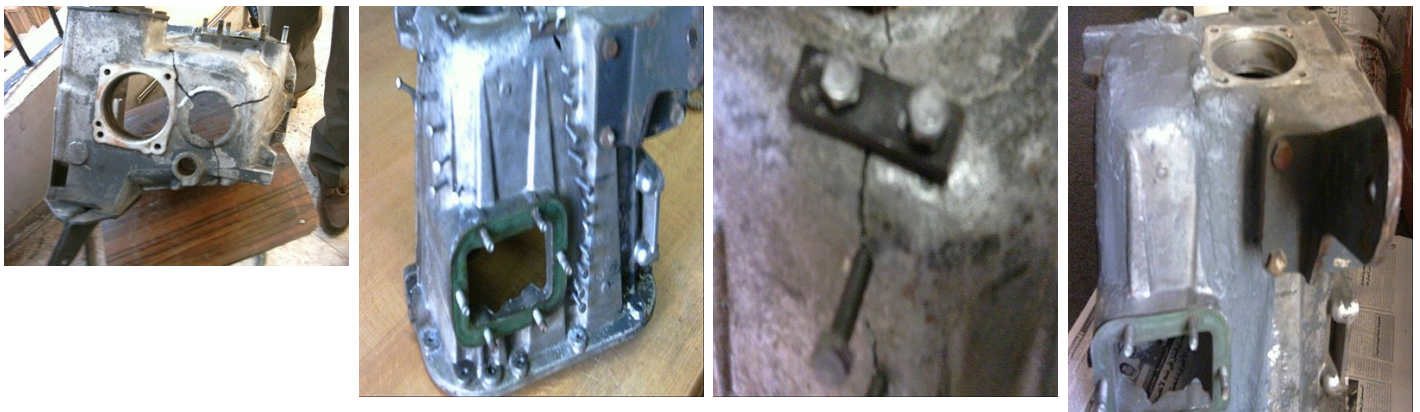
The gear box was badly cracked and fractured.

- * Fractured gear box ,
- * Stabilizing the long cracks of the gear box ,
- * Using metal strips to reinforce the crack ,
- * Repair completed after applying Belzona® 1111 to the cracked surface ,

The gear box had many long deep cracks which were dangerous to be welded due to heat distortion and the high ability to fail again. Belzona repair was completed quickly, safely, without heat, and at a moderate price.

Application was carried out in accordance with Belzona Know-How System Leaflet ENC-1 and ENC-3a. The original dimensions were restored then Belzona® 1111 was used in conjunction with Belzona® 9341 to complete the repair, finally bearing housing was bored to its dimensions.
