# BELZONA REPAIRS DAMAGED GEAR BOX

ID: 569

Customer Location: Petrochemical facility, Egypt  
Application Date: October 2003

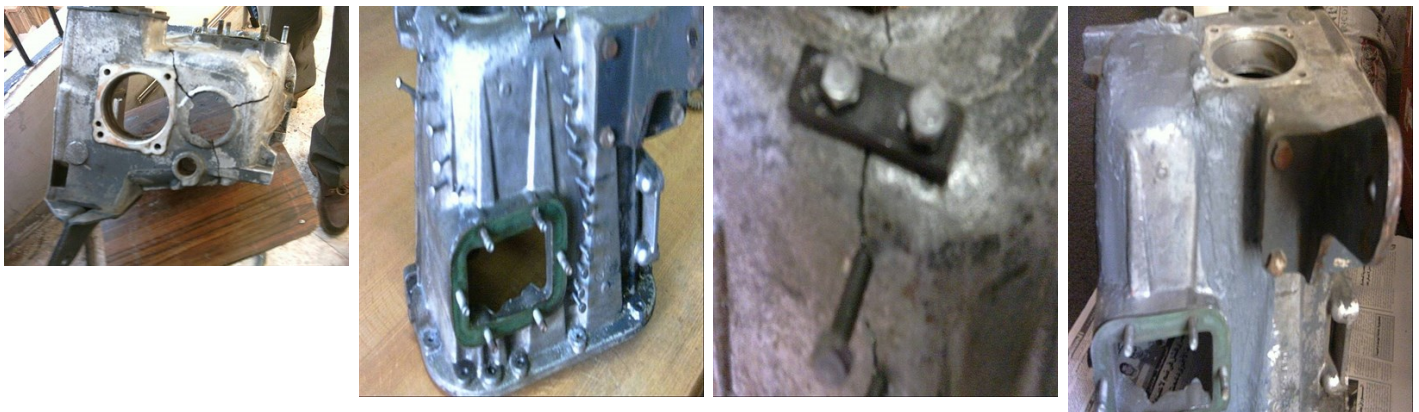
The gear box was badly cracked and fractured.

- \* Fractured gear box ,
- \* Stabilizing the long cracks of the gear box ,
- \* Using metal strips to reinforce the crack ,
- \* Repair completed after applying Belzona® 1111 to the cracked surface ,

The gear box had many long deep cracks which were dangerous to be welded due to heat distortion and the high ability to fail again. Belzona repair was completed quickly, safely, without heat, and at a moderate price.

Application was carried out in accordance with Belzona Know-How System Leaflet ENC-1 and ENC-3a. The original dimensions were restored then Belzona® 1111 was used in conjunction with Belzona® 9341 to complete the repair, finally bearing housing was bored to its dimensions.
