# BELZONA ENGINE BLOCK REPAIR AND PROTECTION

**Customer Location:** *Iron and steel manufacturing factory,  
Egypt*

**Application:** *ENC-Engines and Casings*

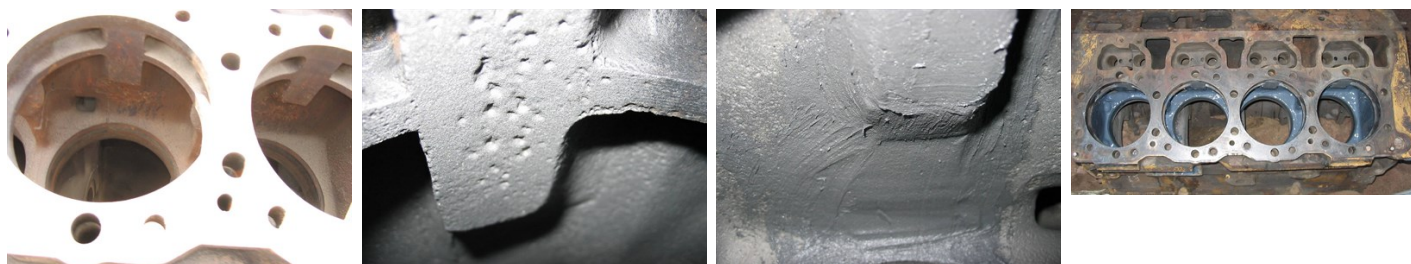
*Cavitation and corrosion in water passages of engine block.*

- \* General view of the block ,
- \* Cavitation area after blasting ,
- \* Rebuilding cavitation area using Belzona® 1311 (Ceramic R-Metal) ,
- \* Applying Belzona® 1391 (Ceramic-HT) to the block ,

Application was carried out in accordance with Belzona Know-How System Leaflet ENC-6.
